**Flood Control Project Maintenance  
Levee Inspections**

**Fall 2008 Levee Maintenance Deficiency Summary Report**

**Reclamation District No. 2058**

Waterway			Bank	Unit Miles
Unit No. 01 Paradise Cut			Left	6.70
	Spring (March - May)	Summer (June - August)	Fall (September - November)	Winter (December - February)
Date of Inspection	5/8/2008		9/18/2008	
DWR Inspector	Richard Willoughby		Hana Babbin	
Accompanied By				
Unit Maintenance Rating (Fall Only)			U

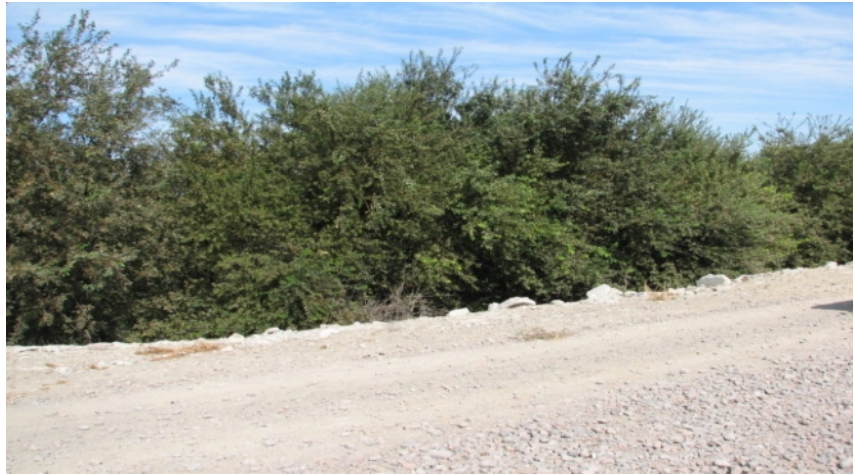
Levee Mile Report Line	3
Start Levee Mile	0.82
End Levee Mile	0.93
Location	
Category	Earthen Levee
Item	Trim / Thin Trees
RD 2058: Significant density of trees along the WS of this levee.

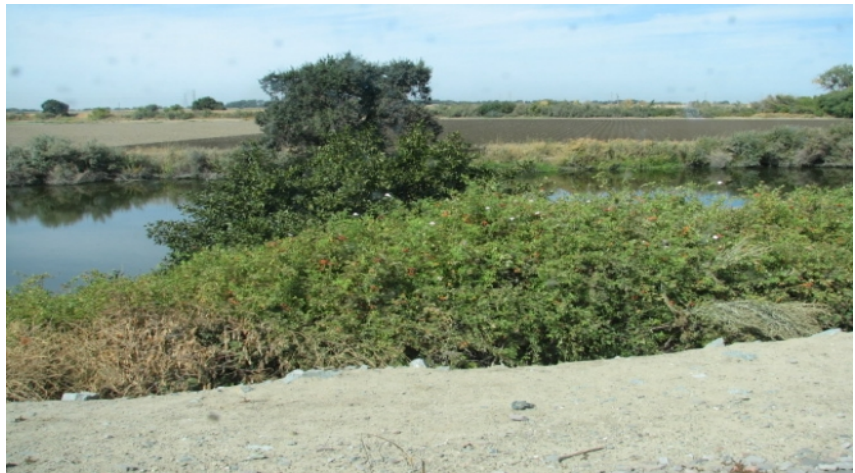
Levee Mile Report Line	6
Start Levee Mile	1.30
End Levee Mile	1.30
Location	
Category	Earthen Levee
Item	Vegetation
RD 2058: Elderberries present on WS but cannot be removed due to environmental constraints.

5	1.29	1.33	Earthen Levee	Vegetation	WS	U	Remove the wild growth other than native grasses from the levee slopes.	37.802495 ° -121.401157 °	37.802652 ° -121.400542 °		6
6	1.30	1.30	Earthen Levee	Vegetation	WS	U	Elderberries are blocking visibility and flood fight capability.	37.802553 ° -121.400970 °	37.802553 ° -121.400970 °	Y	15
7	1.35	1.38	Earthen Levee	Vegetation	WS	M	Elderberries are blocking visibility and flood fight capability.	37.802737 ° -121.400201 °	37.802886 ° -121.399551 °		16
8	1.76	1.86	Earthen Levee	Trim / Thin Trees	WS	U	Trim and thin trees to allow visibility of the ground and room to flood fight.	37.804462 ° -121.393150 °	37.804798 ° -121.391413 °		17
9	2.80	2.80	Earthen Levee	Encroachments	LS	M	Debris	37.801278 ° -121.374873 °	37.801278 ° -121.374873 °	Y	18
10	3.07	3.07	Earthen Levee	Slope Stability	LS	M	Repair slope instability.	37.800137 ° -121.370370 °	37.800137 ° -121.370370 °	Y	8

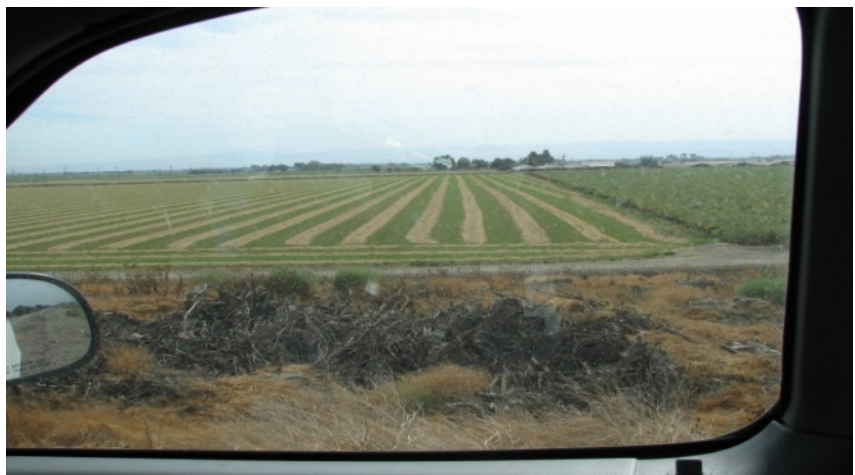
Levee Mile Report Line	9
Start Levee Mile	2.80
End Levee Mile	2.80
Location	
Category	Earthen Levee
Item	Encroachments
RD 2058: Large debris pile within 10' of levee toe. Impedes flood fighting and provides habitat for rodents.

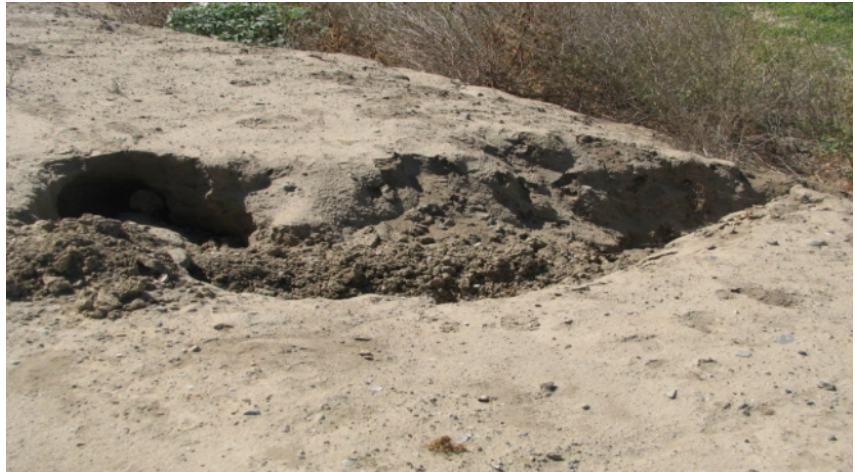
Levee Mile Report Line	10
Start Levee Mile	3.07
End Levee Mile	3.07
Location	
Category	Earthen Levee
Item	Slope Stability
Landside slope erosion cause by runoff at LM 3.07

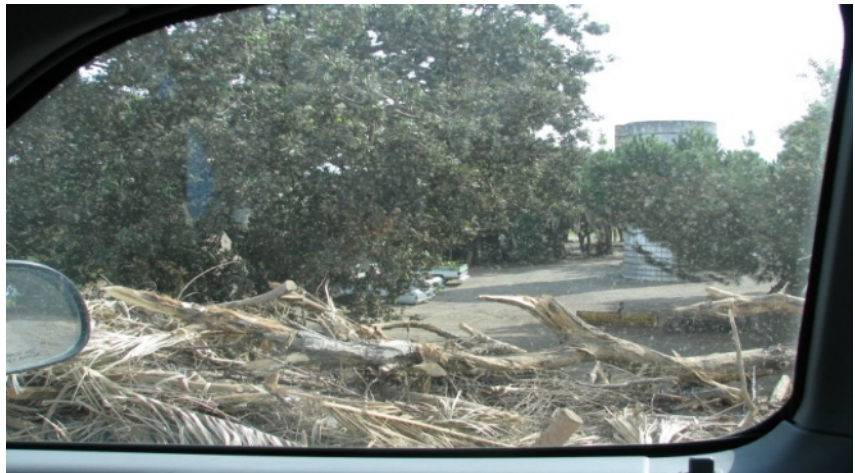
Levee Mile Report Line	12
Start Levee Mile	4.13
End Levee Mile	4.13
Location	
Category	Earthen Levee
Item	Encroachments
RD 2058: Fairly large debris pile on LS, impedes flood fighting and visibility of levee slope.

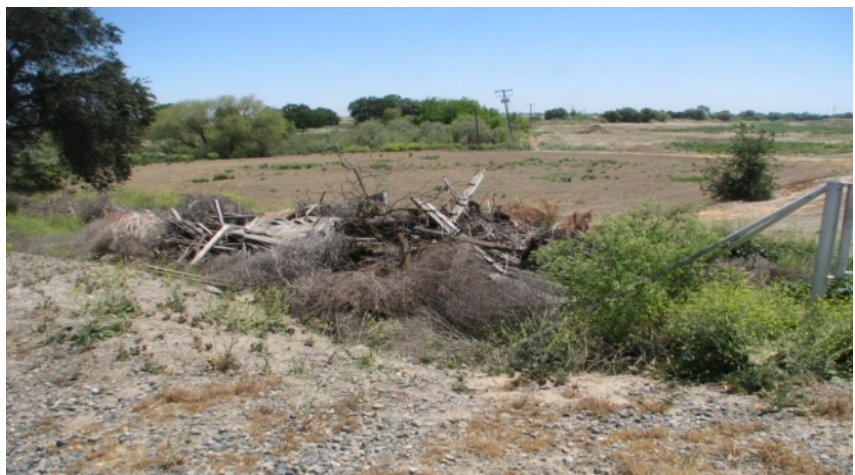
Levee Mile Report Line	18
Start Levee Mile	6.01
End Levee Mile	6.01
Location	
Category	Earthen Levee
Item	Encroachments
Garbage on waterward slope at LM 6.01
